## Collingbourne Ducis Infiltration Reduction Plan Summary

## **April 2024 – March 2025**

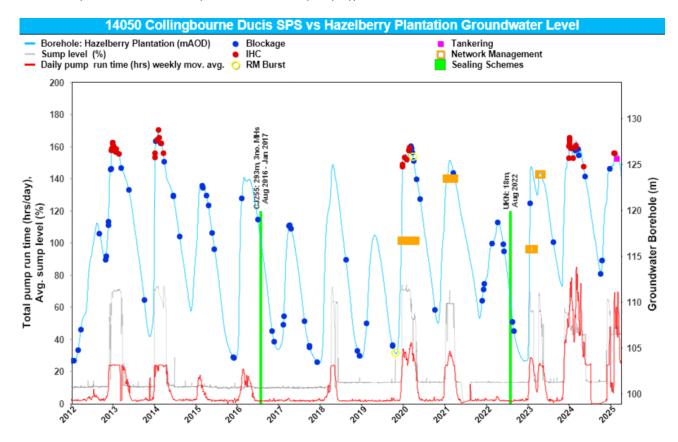
The graph below displays incidents against local groundwater levels, and the telemetry at Collingbourne Ducis Sewage Pumping Station (SPS). There is a correlation between groundwater levels and pump run times, though the network only becomes inundated during very high groundwater levels. Sewer sealing was completed in the catchment in 2013 and 2016, and improvements at the SPS were carried out in August 2023 however, incidents attributed to inadequate hydraulic capacity were reported in winter 2023/24 and 2024/25. Tankering was utlised in February 2025 was enable improvements to the pumping station.
