# Bagstone and Tytherington Infiltration Reduction Plan Summary

## April 2024 – March 2025

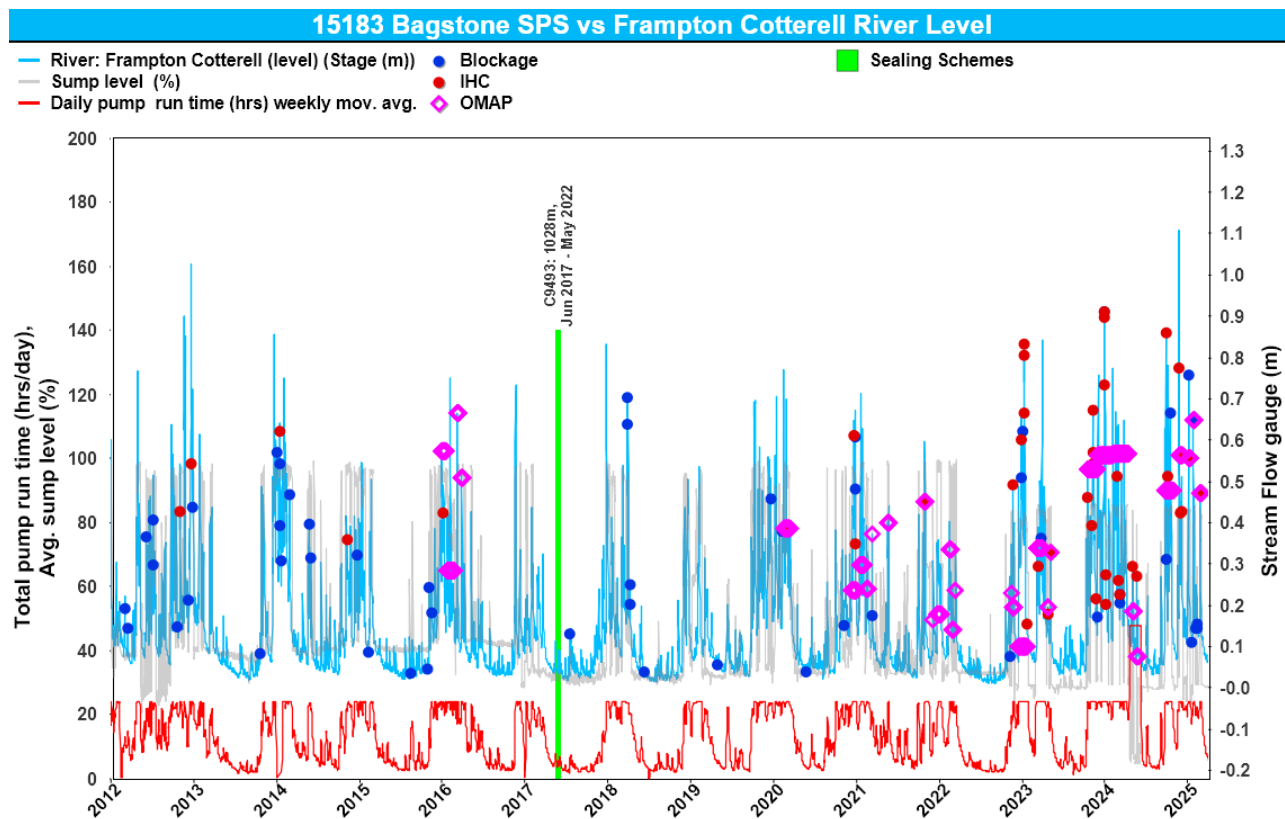
## Current Performance
