# Bleadon Infiltration Reduction Plan Summary

## April 2024 – March 2025

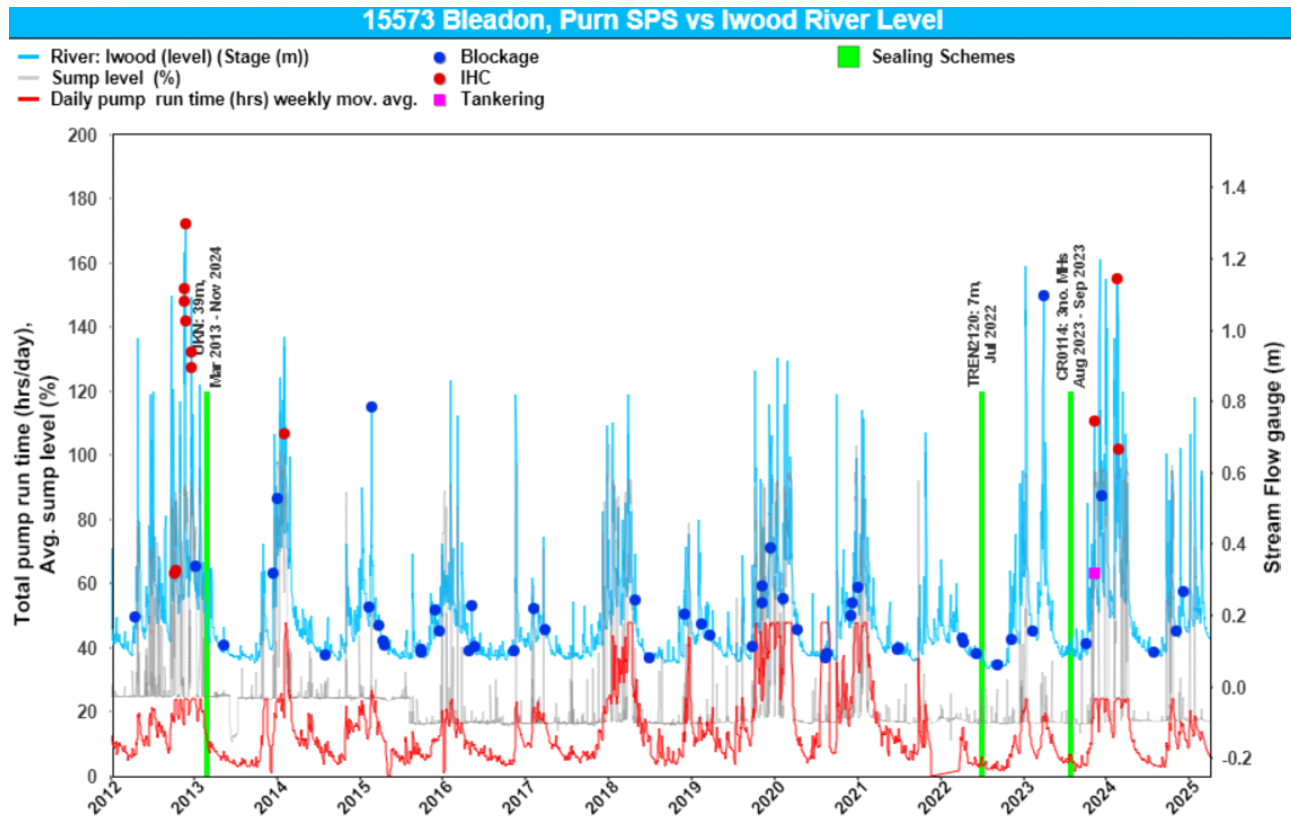
The graph below compares the Iwood River level and telemetry at Bleadon Purn Sewage Pumping Station (SPS). The river level is used to indicate groundwater levels in the area. The pump activity at the Bleadon Purn shows a clear correlation with groundwater, showing the impact of infiltration on the network. Incidents attributed to inadequate hydraulic capacity (IHC) were reported in the catchment during the exceptionally wet winter of 2023/24.
